Survey of the Actual Conditions of Wood Processing for Reusing Ise-jingu Shrine's Old Materials

Rie Nakayama **

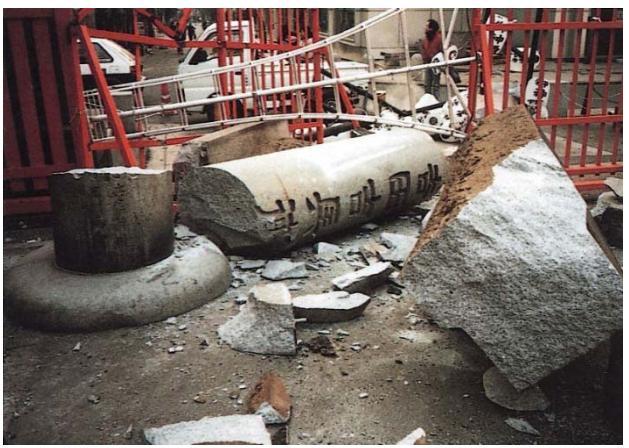
The haiden of Ikuta Shrine was rebuilt using the cutting-edge technology at that time. It was erected on pillars using ultrahighstrength concrete-filled steel pipes and on brackets reusing existing wooden "To-kyo" and hut frames²¹). Furthermore, the stone "second torii," which was inside the boundaries at the time of the earthquake, collapsed owing to the earthquake and the constituent parts, such as the pillars nuki (penetrating tie beams) and kasagi (top beam), were crushed, making it difficult to reconstruct through repair²²).

Figure 4. The broken "second torii" of Ikuta Shrine "Record of Ikuta shrine recovery from Great Hanshin-Awaji earthquake"(2000)

However, old materials that have been used for over sixty years to construct main building ridge pillars and Ujibashi torii to Sekijuku torii have greatly deteriorated in terms of both pillars and Kasagi (top beam). Therefore, a proposal was made by the Design Department of the Osaka Head Office of the Takenaka Corporation, who were in charge of the design, to reinforce the pillars with steel pipes and fiber-glass reinforced plastic (FRP)²⁴⁾. The pillars were split vertically in two and the internal rotten areas carved out. They were then reinforced with FRP, and steel pipes were inserted within the hollow section. In the same way, the Kasagi (top beam) were split lengthwise into two. After digging out the rotten section, the insides were reinforced with glass fiber and epoxy resin. A lightweight reinforcing rib was installed with the resin version, and the gap was reinforced by filling it with FRP.

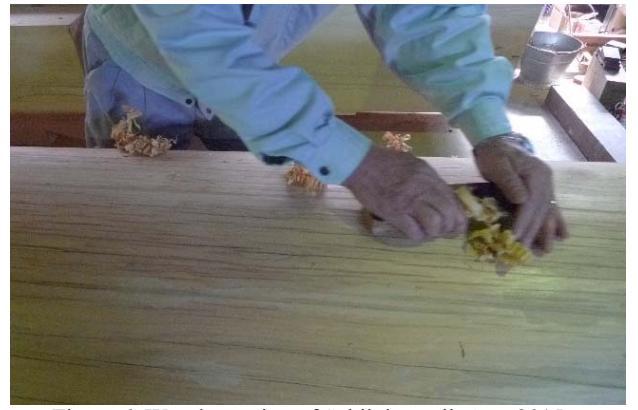
Figure 6. Wood scraping of Sekijuku torii, Apr. 2015

Wood surface finishing was performed using a finish cutter on a plane after shaving the wood surface as a whole using apparatus such as a grinder. Approximately 3–4 mm of the wood surface was carved out simultaneously. After carving out the surface that had turned grey over the 20 years that had passed, a bright wood surface appeared. Fine cracks appeared all over the pillar's surface. As it was difficult to remove traces of the aging that had infiltrated the cracks, greying cracks were found amongst the bright wood surface, presenting an aspect unique to the reused materials. [Fig.6] This did not stand out when viewed from a distance, and according to the survey we conducted, the reason for shaving this was that it had been white wood since it was standing in Ise. Thus, when reconstructing this, it seemed natural to return the wood surface to its beautiful, white wood state²⁹).

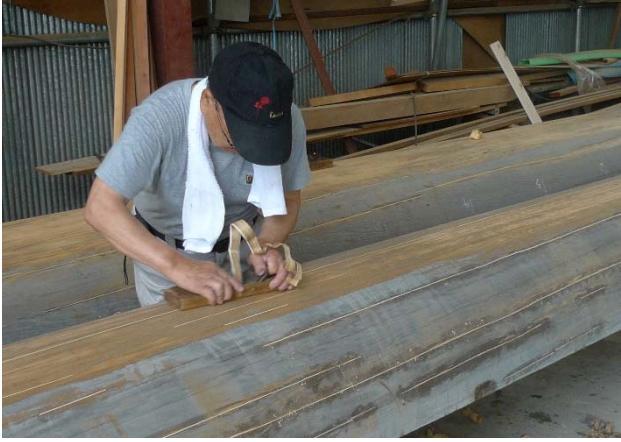
Figure 9. Wood scraping of Ikuta Shrine Torii, Aug. 2015

In terms of the finishing of the wood surface, the bestowed old materials were all hand-carved using a plane. An arm was attached to the platform and blade of the plane, in accordance with the diameter of the column, and a plane processed in the shape of an inner-rounded plane was used. Plane processing was performed manually by a carpenter. Cracks in the wood surface were observed when reusing materials from the Ujibashi tori. In the Sekijuku tori, they were observed in an even broader range with the passing of time. These cracks were filled with new cypress wood. [Fig.9] The plane was used 20–30 times until the greying surface of the wood surface could no longer be seen; however, in some areas, the grey layer was particularly deep or it was difficult for the blade of the plane to enter, making the work

more troublesome than initially expected. Generally, the plane did not slide as well as with new materials, and manual processing required more physical strength. Thus, occasionally, a cord was attached to the plane and pulled by two people. The shaving thickness was around 3–4 mm.

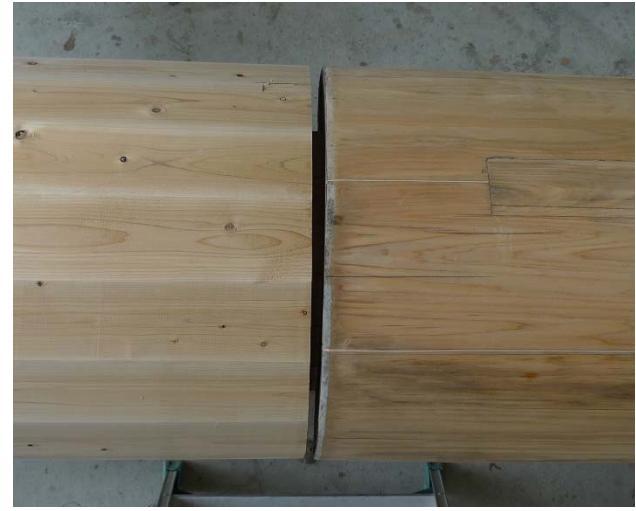
Figure 10. comparison of the colour of surface left: new material, right: old material

Surfaces on which the wood scraping was applied were bright and smooth. A visual comparison of these surfaces with the new material revealed that there were some areas that seemed to be more tinged with brown when finished. [Fig.10] When we asked the reason for performing wood scraping, the objective stated was to clean the dirt from the surface of the wood surface in order to make the old materials look like the new materials.

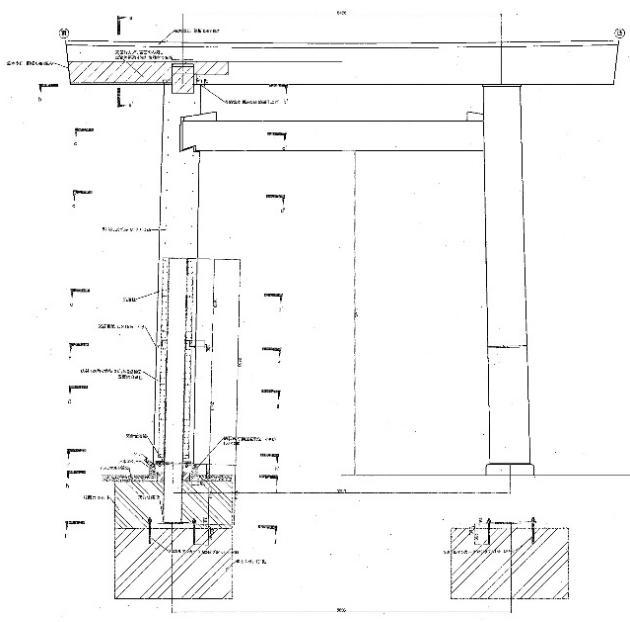
Figure 11. "Second torii of Ikuta shrine Renovation Plan" (2015)

The total height of the torii on the plans was approximately 7450mm, and the pillar diameter was 660mm-680mm for the existing section and approximately 690mm for the laminated section, with the kasagi (top beam) height was 772mm, and penetrating tie-beam height was 508mm. Each of them was 10–20 mm smaller when compared to the Sekijuku torii. Furthermore, the total length of the pillar, including the footing of the steel pipe, was approximately 7470 mm, with the original material length of 4470 mm and the length of the laminated material section being 2000 mm.[Fig.11]
