Survey of the Actual Conditions of Wood Processing for Reusing Ise-jingu Shrine's Old Materials

Rie Nakayama **

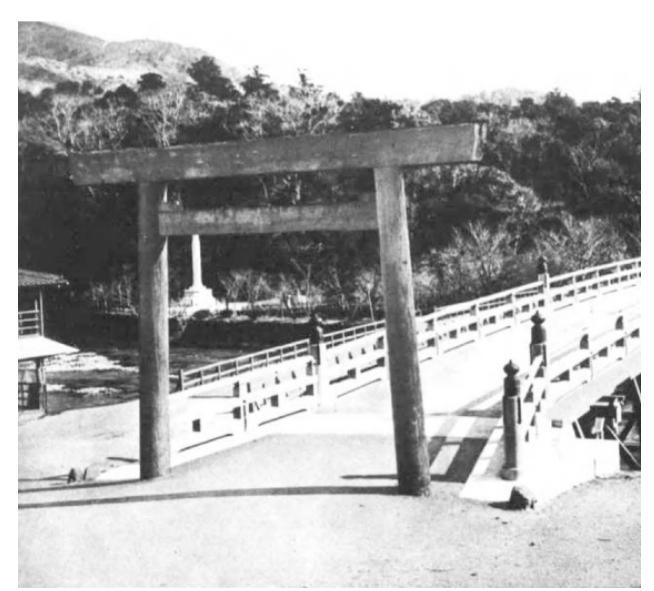
Figure 1. Ujibashi Torii in Ise city, 1931 Chusei-do "The great album of Japanese scenic spots and customs" (1931)

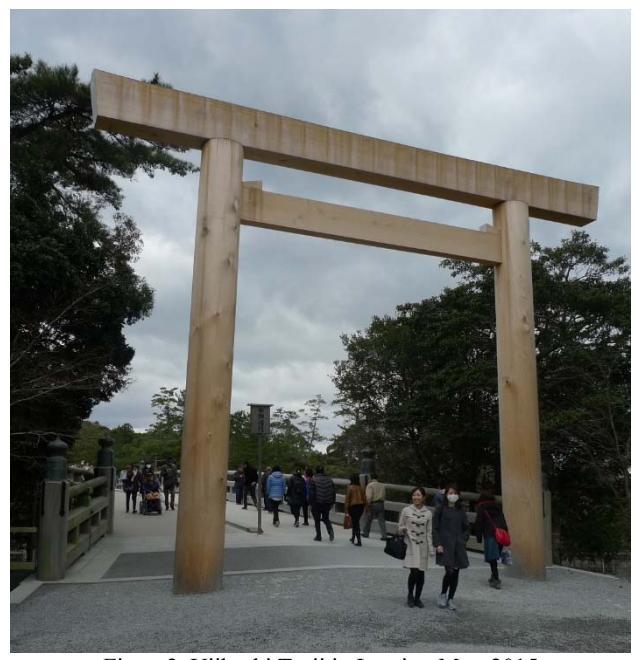
Figure2. Ujibashi Torii in Ise city, Mar. 2015

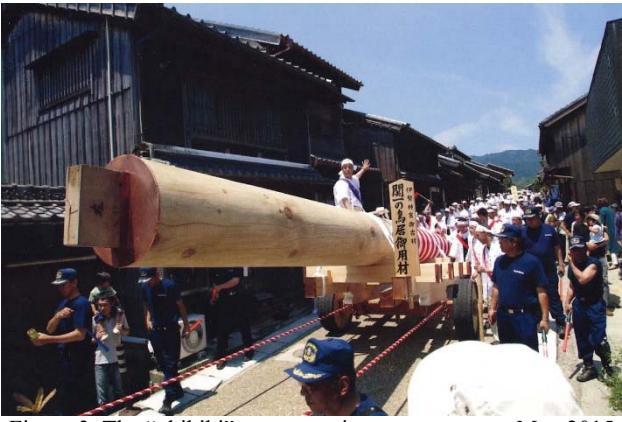
approximately one year after the Ise-jingu Shrine Shikinen Sengu, and the re-processing, "okihiki" and completion work being carried out six months after that, has continued until this day¹⁷. [Fig.3]

Figure 3. The "okihiki" ceremony in Kameyama City, May 2015 'Tokaido Sekijuku Eastern Fork "Ichino-Torii" Okihiki Commemorative Edition in the 27th year of Heisei' (2015)

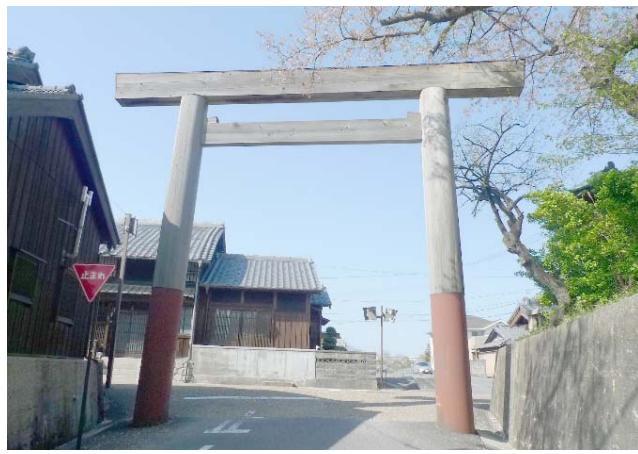
Figure 5. Sekijuku torii in Kameyama City, Apr. 2015

Wood surface finishing was performed using a finish cutter on a plane after shaving the wood surface as a whole using apparatus such as a grinder. Approximately 3–4 mm of the wood surface was carved out simultaneously. After carving out the surface that had turned grey over the 20 years that had passed, a bright wood surface appeared. Fine cracks appeared all over the pillar's surface. As it was difficult to remove traces of the aging that had infiltrated the cracks, greying cracks were found amongst the bright wood surface, presenting an aspect unique to the reused materials. [Fig.6] This did not stand out when viewed from a distance, and according to the survey we conducted, the reason for shaving this was that it had been white wood since it was standing in Ise. Thus, when reconstructing this, it seemed natural to return the wood surface to its beautiful, white wood state²⁹).

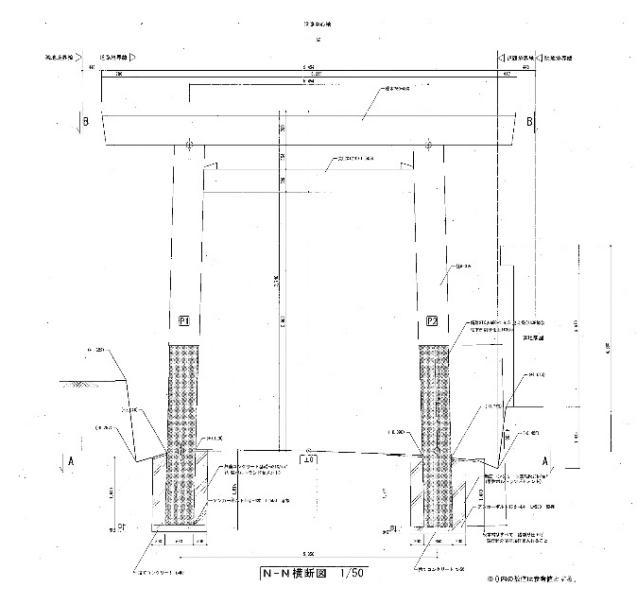
Figure 7. "East Fork Torii Reconstruction Cross-Sectional Drawing" (2014)

In the drawings, the height of the torii was 7740 mm, its footing was 1,714 mm, the kasagi (top beam) height was 760 mm, the penetrating tie beam height was 520mm, and the pillar diameter was 690 mm. When measuring the total length of the pillars from the plan, it was approximately 8,750 mm, of which 7,000 mm represents the inside of the torii. Furthermore, 4,130 mm from the lower pillar section is covered with steel pipes with a diameter of 650 mm and thickness of 9.5 mm, with a section of 2,400 mm from the ground being represented by steel pipes³⁰. [Fig.7] Sekijuku torii is constructed on a general road through which

ordinary passenger vehicles can pass. When it was rebuilt in the 50th year of Showa (1975), an H steel root coil was installed with the aim of preventing collisions or destruction from accidents. However, in consideration of the background, in the 7th year of Heisei (1995), it was reinforced with a steel pipe that virtually had the same diameter as the pillar. [Fig.5] Furthermore, as the pillar root section had deteriorated the most, the area around the steel pipe was filled with wood to fill the gap with the comparatively sound parts. Furthermore, the length between the pillars was 5,454 mm at the top section of the pillar, which is exactly 18 shaku. When reconstructing the torii, the rotten sections of the reused materials were reinforced by filling them with wood, and the existing mortise of the pillars and kasagi (top beam) was used as is. From the above, it can be concluded that it is necessary to consider wood scraping and shrinking due to aging. However, we can see that the Sekijuku torii virtually follows the dimensions of the old materials from Ujibashi torii.

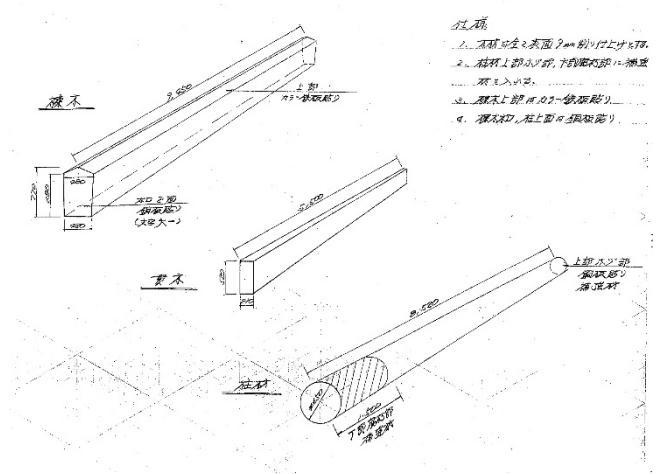
Figure 8. "Sekijuku Torii Specification Diagram" (1995)

Furthermore, a specification diagram was found (hereafter "Sekijuku torii specification diagram") when the Sekijuku torii was reconstructed in the 7th year of Heisei (1995) in Kameyama City. This is a summary plan, but it outlines the dimensions of the kasagi (top beam), penetration tie beams, and pillars, and we know that wood was shave-finished to 9 mm across the surface. All the parts were reused and wood scraping was performed. Additionally, the length of the pillar materials was 8,520 mm, and as part of this, the materials of the deterioration in the lower section was 1,500 mm, the pillar root section diameter was 650 mm, the kasagi (top beam) height was 770 mm³¹). [Fig.8] Compared with the drawing plans for the 16th year of Heisei (2014), the pillar diameter and pillar length were 30 mm and 230mm smaller, respectively, but the size of the kasagi (top beam) and penetration tie-beams were virtually the same. Even when the differences in the carve-out thickness are considered, the fact that the pillar materials in the 7th year of Heisei (1995) are different is attributed to the year and shrinkage. Deterioration

due to aging differs, and this changes the size of the exclusion and shaving of rotten materials³²).

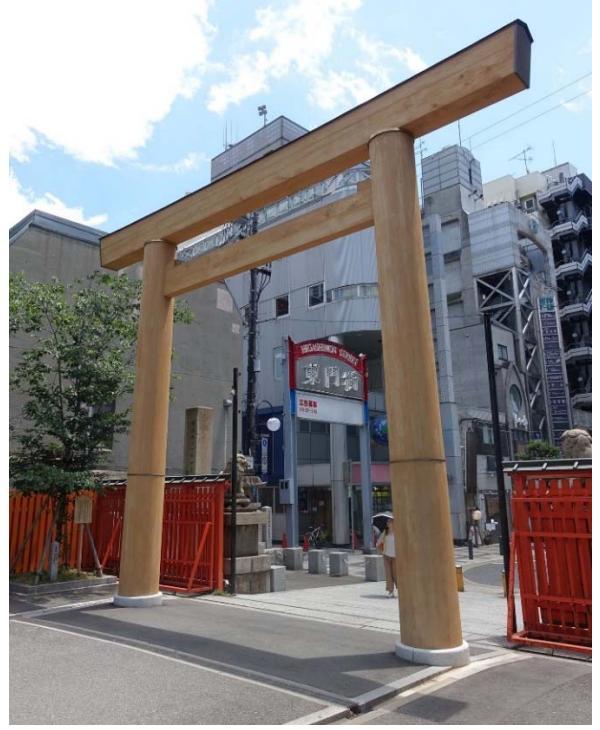
Figure12. Ikuta shrine torii in Kobe City, 2017
